Monitoring prior to BMP stormwater management installations on PERT property

October 2006

Laura Toran, Department of Geology, Temple University

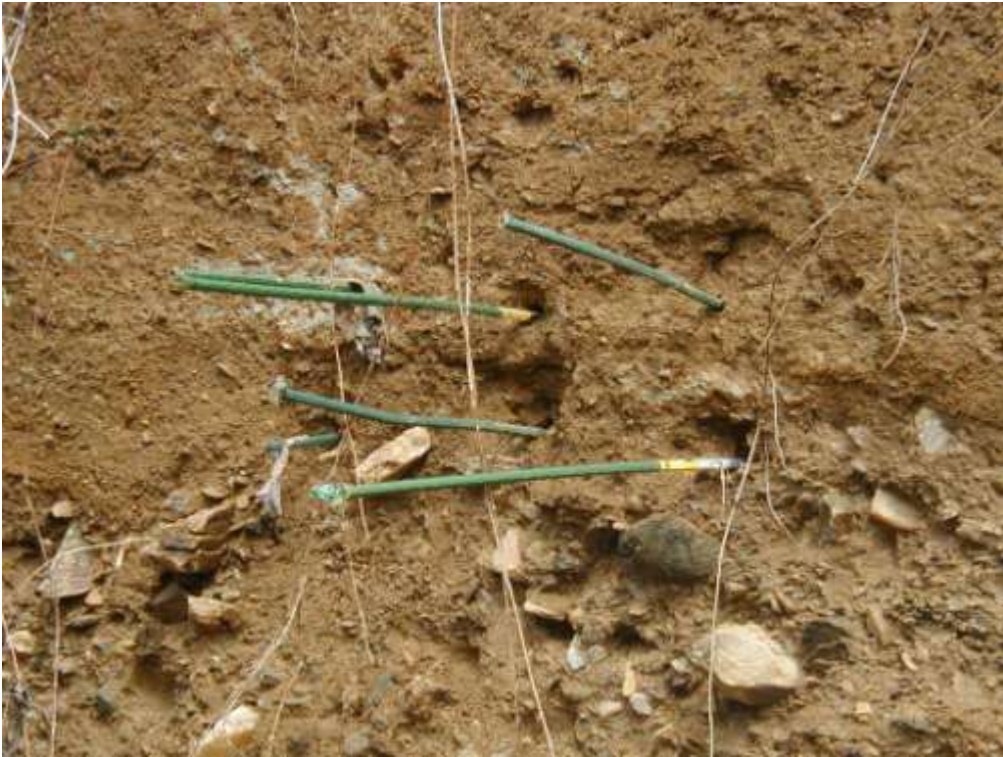
Pins in bank, site 1, Terwood Run

Bank pins were installed at 4 sites along the reach of Terwood Run. Two rows of pins were hammered into exposed banks and their lengths were measured. The pin lengths were measured again approximately monthly. Erosion appeared to be episodic. In December (after a snow melt) there was 10 to 15 cm erosion shown in the measurement of pins. In the spring and summer when water levels and stormflow were not as high, there was little change in the pin lengths (2 cm or less). Recently, growth of vines has covered some of the pin sites which further inhibits erosion. Some additional pins have been installed to provide more complete coverage.

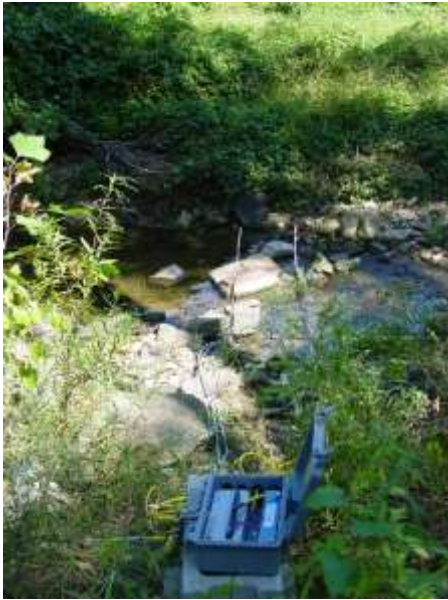
Data logger at Terwood Run, measures water level, conductivity and temperature

Data loggers were installed at two locations at PERT. The loggers recorded temperature, water level, and conductivity of the water (a measure of dissolved ions) at 15 minute intervals. One logger was installed near the PERT office where a storm pipe moves water from the parking lot to a small pond below. A second logger was installed on Terwood Run downstream of the proposed stormwater management project. The loggers were installed in early October 2005, but some of the early data were lost due to a large storm which flooded the sites. The loggers have continued to collect data until late August 2006, when a large storm brought debris down Terwood Run which cut the wires for that logger. A new logger has been installed but there was a gap in the data.

The logger on Terwood Run recorded around 65 storms of various sizes. In the fall and winter, water level increases of 5 to 60 cm were observed. The largest increases were associated with rainfall that melted snow. In the spring, stormflow increased the water level 5 to 30 cm and in the summer the range was 1 to 12 cm. Conductivity may increase or decrease during storms, depending on whether dilution or mobilization of urban water is dominant. The most prominent example of mobilization of urban water is during snow melt when the conductivity was observed to increase up to 1600 uS/cm. This increase is associated with road salt and is estimated at 300-500 mg/L of dissolved salt at the peak. Mobilization of road salt at this and other sites has been observed in all four seasons, and it is believed that pockets of salt remain after winter de-icing. So far there is only 2 months of data since the wetland was installed so there are not yet sufficient data to compare response before and after.
